# Legionella Risk Assessment of Hot & Cold Water Systems

**RA4983**

**Leeds Yorkshire Housing Association  
Harrison Potter Trust Almshouses  
Raglan Road  
Woodhouse  
LS2 9ED**

**9th January 2019**

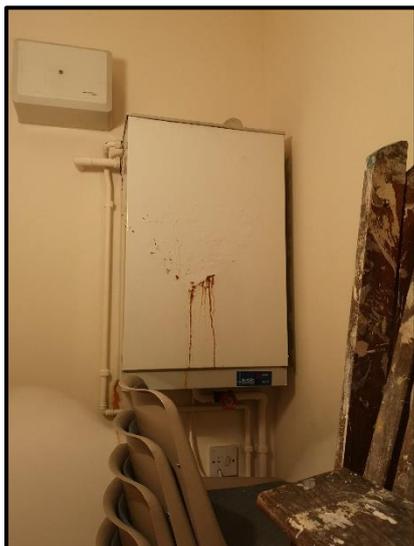
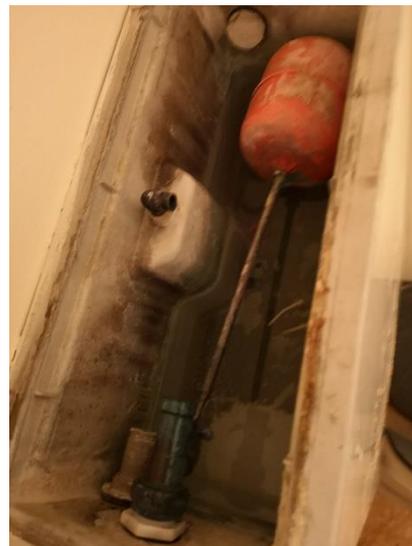
COMBINATION STORAGE WATER HEATER (CSWH) DATA	
Combination Storage Water Heater Reference	2
Water heater location	CSWH 1
Type of Unit (make / model / heat source)	Ground Floor Left Handside Toilet
Single or Multipoint?	Santon Rectangular Power Heater Multi
Approximate cold water content (Litres)	10 Litres
Approximate hot water content (Litres)	45 Litres
Materials of construction	Copper
Access & ease of cleaning to header tank	Good & Good
Unit & outlets clearly labelled	No
Supply source ( Mains / Tank i.e. CWST1)	Mains
Hot temperature °C	50
Cold temperature °C In/Store	10
Appearance of water/Tank	Contaminated – Tank is dirty

CSWH RISK ASSESSMENT						
Parameters	Potential Risk					
	Low 10 points ✓		Med. 20 points ✓		High 30 points ✓	
Formation of droplets	Still water		Droplets	✓	Aerosol	
Water condition	Clean		Contaminated	✓	Heavily contaminated	
Water temperature	Above 60°C		46°C – 59°C	✓	26°C – 45°C	
Water turnover	High turnover		Mod. Turnover	✓	Low turnover	✓
Susceptibility of exposed persons	Low		Average		Susceptible pop.	
Population density	Low density	✓	Medium density		High density	
Score 60 – 100 = Low Score 100+ – 140 = Medium Score 140+ = High					<b>120 – Medium Risk</b>

REMEDIAL REQUIREMENTS ✓	
Clean and disinfection	✓

<b>Client</b>		Leeds Yorkshire Housing Association		
<b>Site</b>		Harrison Potter Trust Almhouses Raglan Road Woodhouse LS2 9ED		
<b>Date of Inspection</b>		9th January 2019		
<b>Inspecting Body</b>		Water Hygiene Services Ltd		
<b>Grade</b>		<b>A = Immediate</b> <b>B = Recommendation</b>		
No.	Item	Description	Grade	Actioned/ Comments/ Date
1.	Training	Ensure the Responsible Person has had the relevant ACOP L8 training within the last 2 years.	A	
2.	Control Scheme	Ensure that a Control Scheme is in place, log book kept up to date and that any recommendations are actioned.	A	
3.	CSWH	Clean and disinfect.	A
